Defence
Safety
Authority

Service Inquiry

HERCULES C-130J Mk4
(ZH873) Heavy Landing
Incident

25 August 2017

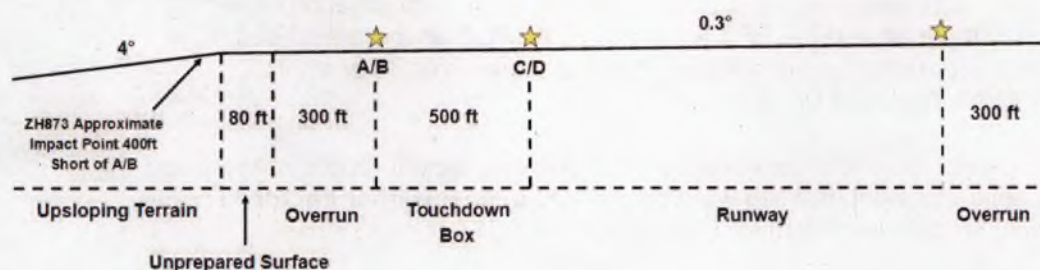
Figure 3 – TLZ Slopes (Not to scale)

1.4.113. Neither of the surveys available to the crew mentioned a significant upslope that immediately preceded the overrun (Illustrated in Figure 3). However, the PNF had sighted separately a previous edition of the partner nation's survey which contained a cross sectional diagram that clearly annotated it. As the PF was not in Herc Det Operations at this time, he had not seen this older survey. However, the PF had spoken to the outgoing pilot during their handover who had stated that there were unusual Rad Alt readings on the final approach. This was confirmed in interview where that pilot also stated that he had not reported this either in the Air Safety Information Management System (ASIMS) or internally within the Herc Det.

1.4.114. The previous edition of the partner nation's survey indicated that the slope preceding the overrun was 5% (2.86°). After the accident, the site operator indicated that it was 4.1°, while satellite imagery suggested that it was 3.9°. Given the variety of data, but the consistency of the latter two, the Panel utilised 4° for its subsequent analysis, as shown in Figure 3.

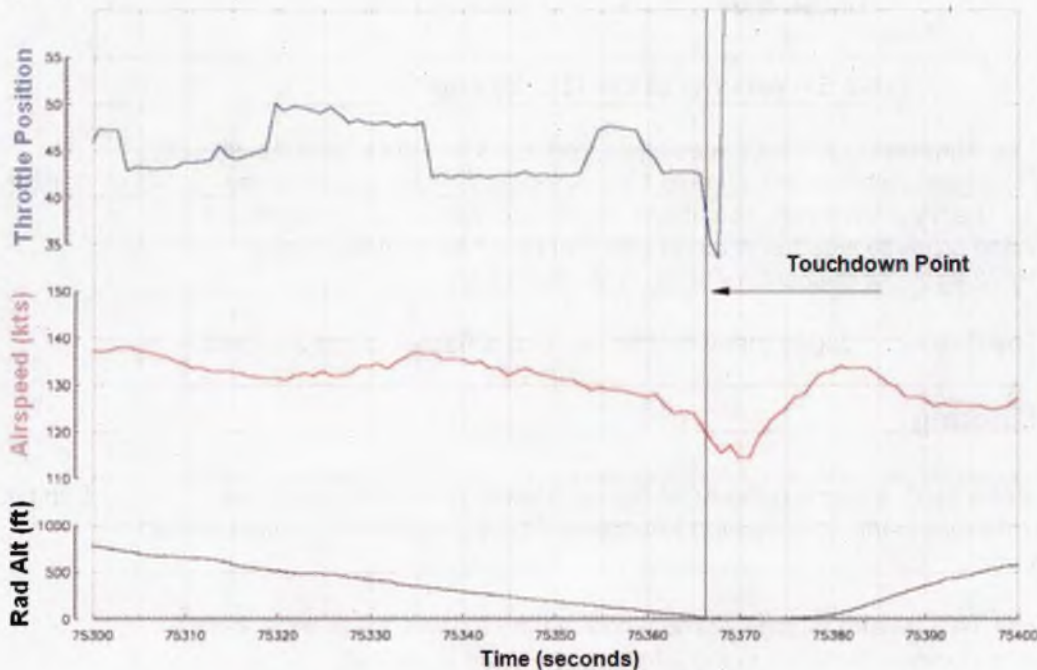
Figure 4 – Throttle Position vs Airspeed

1.4.188. The Air Test and Evaluation Centre (ATEC) stated that during the trial, final power reduction occurred typically 1 to 2 seconds prior to touch down for a normal MOS landing. Figure 4, a DFDR trace of ZH873's throttle position, airspeed and height, demonstrates the PF initiated final power reduction approximately 0.5 seconds before the aircraft impacted the ground. Therefore, compared to other MOS landings, the power reduction seen by ZH873 was actually later than would have been expected.

1.4.189. The Panel determined that there was no evidence of an early and/or excessive power reduction leading to a high rate of descent at touchdown.

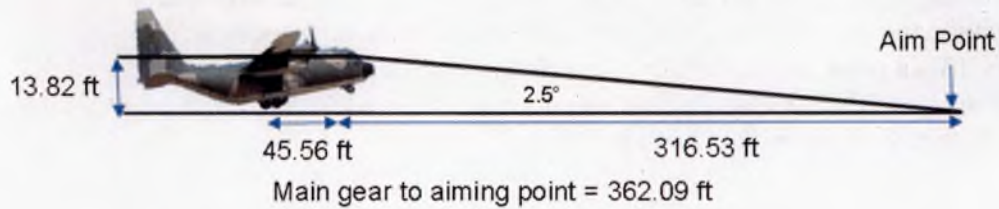
Figure 8 - Main Wheel Touchdown Point – 2.5° Approach / Aircraft Pitched 1.5° Nose Up

1.4.204. However, this analysis is based on the aircraft being in a horizontal attitude whereas the expectation on landing would be for a nose up attitude due to flaring of the aircraft. DFDR evidence indicated that ZH873 had a 1.5° nose up attitude at impact; this would increase the vertical displacement of the pilot from the main wheels to 13.82 ft, but decrease the horizontal distance to 45.56 ft. The net effect of this pitch is for the wheels to touch down 362.09 ft before the Aiming Point, as shown below in Figure 8.

1.4.210. Thus, in the absence of any other factor, from a 2.5° approach and a 1.5° pitch up attitude at landing, ZH873's theoretical touchdown point would have been 362 ft short of the selected Aiming Point. The crew testified that the PF was aiming at or just beyond the start of the Touchdown Box, and evidence states that the aircraft landed 400 ft short of it.

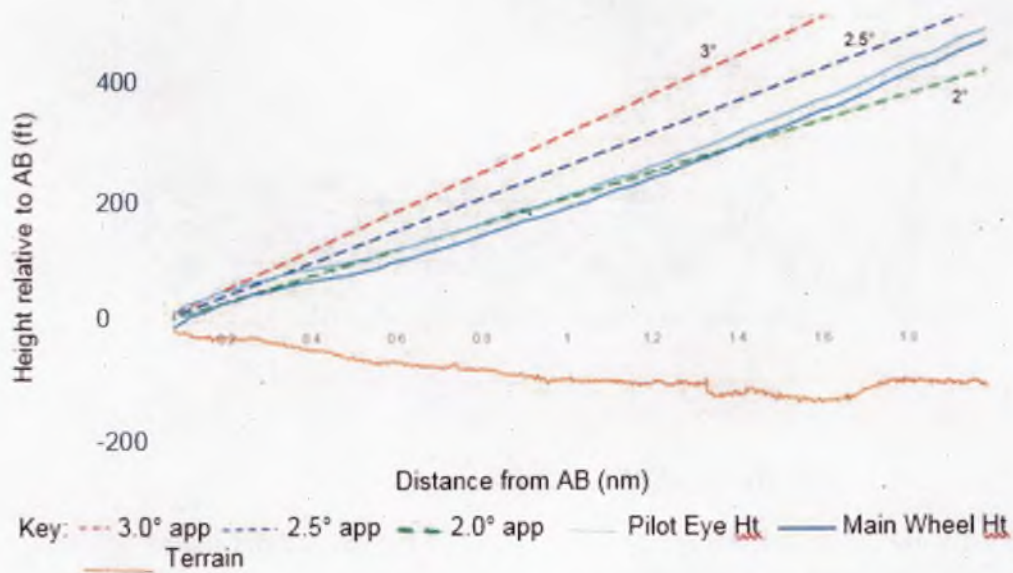
1.4.211. As to the actual glideslope flown, analysis was conducted by ATEC and DAIB. ATEC concluded that the average glideslope flown over the final 1.5nm of the approach was 2.5°, as stated by both pilots. The DAIB analysis suggested that the approach was as shallow as 2° for much of the approach, but recovered to 2.5° during the final 4 seconds before impact, as shown in Figure 11.

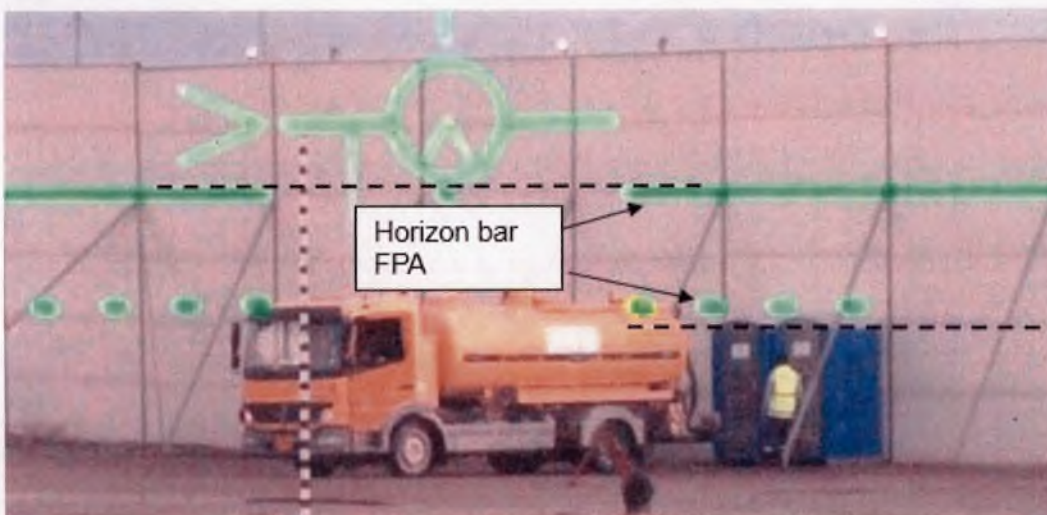
Figure 12 – PF's HUD

1.4.212. Investigation by the DAIB indicated a discrepancy between the HUD imagery displayed to the PF and PNF. Figures 12 and 13 show that the PF and PNF HUDs displayed the Horizon bar and FPA in different positions. Both photographs were taken with the aircraft in the same position, and the FPA set to 2.5°. This was assessed as a misalignment of the 2 Embedded Global Positioning System and Inertial Navigation System Units (EGIs) that provide data to position respective HUD symbology. Given the austere location of the aircraft, full forensic investigation of this potential fault, which could only be achieved with the units in situ, was not possible. The DAIB investigator estimated a potential error of 0.25°, but it could not be determined whether this was isolated to a single EGI/HUD, or a combination of individual errors within each of them.

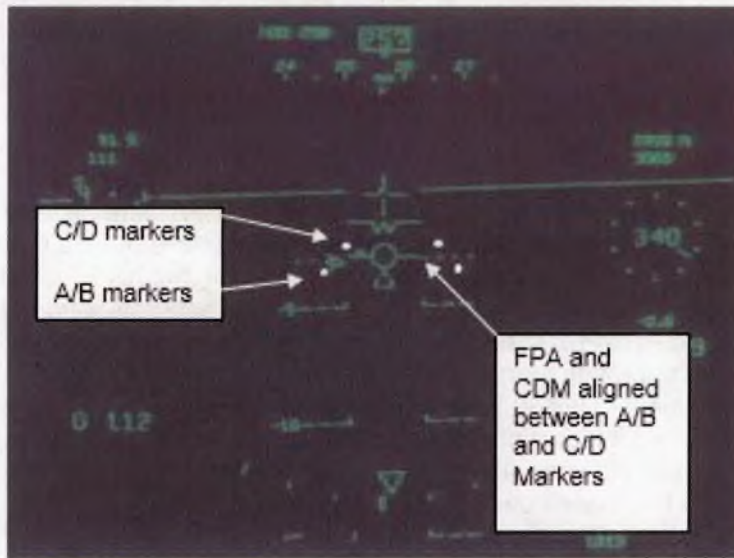
Figure 14 – Aiming inside the Touchdown Box

1.4.218. The Hercules ACM prescribes aiming 150 ft into the Touchdown Box when flying an MOS approach. As outlined in paragraph 1.4.205, the HUD has a number of features to assist this, and Figures 14 to 16 (screenshots taken in the Hercules simulator) illustrate how the FPA and CDM are positioned for three differing aiming points. For the purposes of clarity, the lights delineating the 500 ft Touchdown Box have been enhanced.

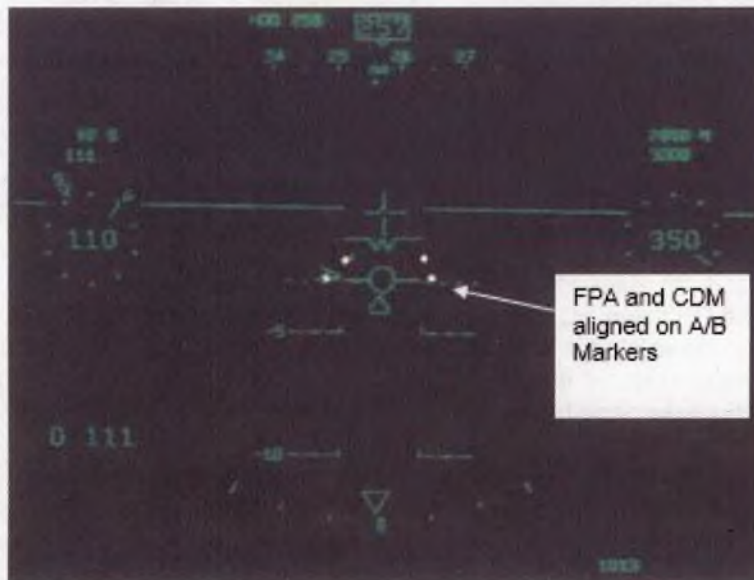
Figure 15 – Aiming at the front of the Touchdown Box

1.4.219. Testimony from both pilots, indicates that the handling pilot was aiming at the front of the Touchdown Box, which was not in accordance with the ACM. As is further discussed at paragraph 1.4.553, the PF indicated that his recent experience of lighter aircraft in the training environment was of a tendency for aircraft to 'float' and touch down towards the back of the Touchdown Box. His selection of an aiming point shorter than mandated reflected his desire to avoid missing the Touchdown Box or floating down the runway, and having to initiate a Go-Around.

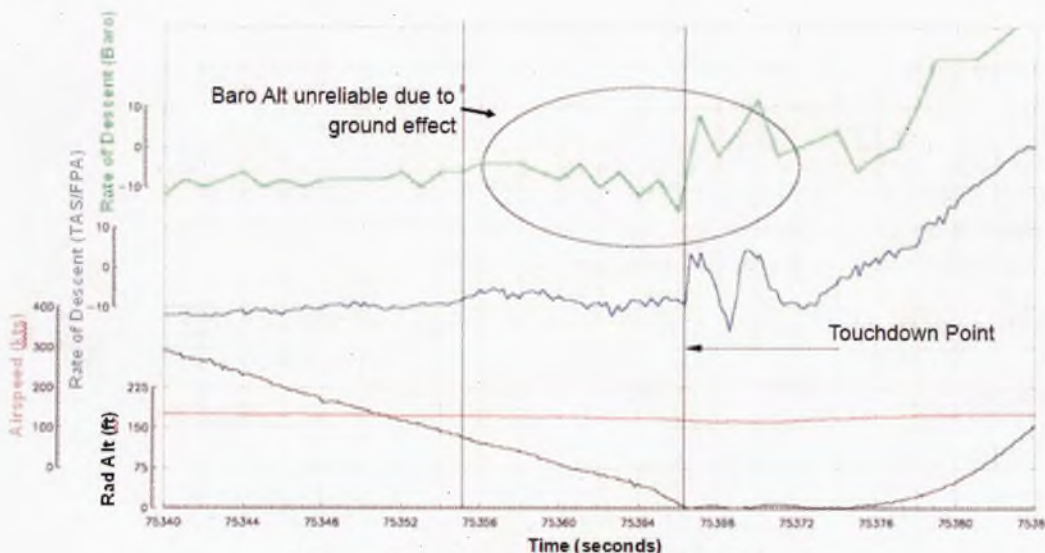
Figure 20 – Rate of Descent Profile

1.4.233. At landing weights in excess of 58,970 kg (as was the case with ZH873), the Hercules RTS limits the landing rate of descent (RoD) to 5 feet per second (ft/s); below that weight the RoD limit is 9 ft/s. An accurate assessment of ZH873's RoD at impact was difficult to calculate due to low sampling rate of the DFDR, and known pressure errors which affect pitot-static instruments as the aircraft enters ground effect. Notwithstanding these issues, QinetiQ flight physicists were able to utilise ZH873's True Airspeed (TAS) and Flight Path Angle (FPA) to determine that the aircraft would have had a RoD of approximately 9 ft/s immediately prior to impacting the ground (Figure 20).

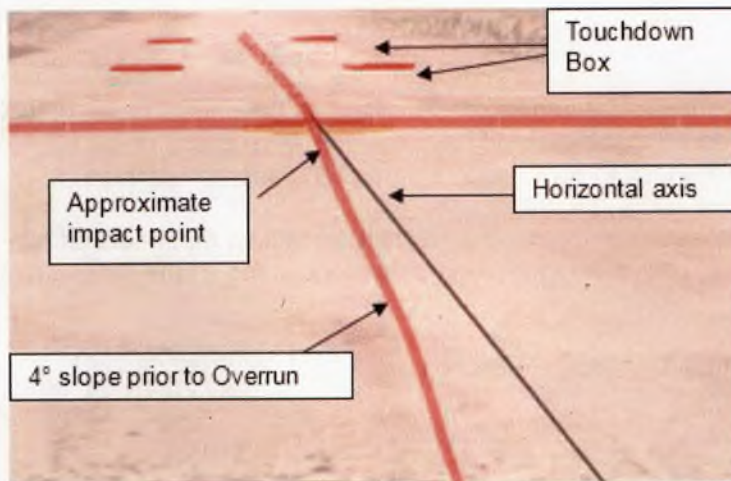
Figure 21 – Slope Preceding Overrun

1.4.235. Light Detection and Ranging (LIDAR) imagery of the TLZ, along with DFDR data, was used to produce a detailed model of the terrain under ZH873's approach. Figure 21 highlights the significance of the slope preceding the TLZ.

1.4.236. Advice was sought regarding the implication of landing on up-sloping terrain, for which ATEC assessed the relative RoD across a variety of gradients (Table 8). This indicates that, had ZH873 touched down on the overrun or runway (with a slope of 0.3°) then the effective RoD would almost certainly have been in the order of 10.10 ft/s. However, the effect of landing on the 4° slope immediately prior was to increase this to 23.77 ft/s, in excess of 4 times the limit prescribed by the RTS, and more than twice that cleared by the Lockheed Martin.

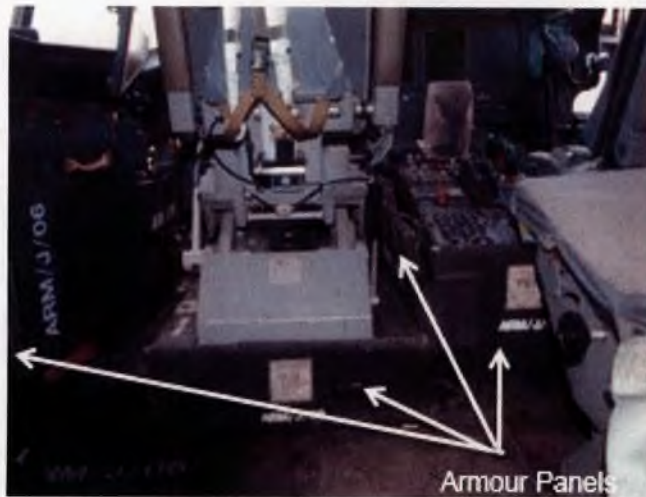
Figure 27 – Flight Deck Armour

1.4.378. The Flight Deck Armour (FDA) and Weapon Stowage are installed as a complete system (MOD/HECJ/1057 & MOD/HERCJ/1073); all off aircraft maintenance is completed by Marshall Aerospace and Defence Group at BZN in accordance with DAP101B-0704_5-5A3 and DAP101B-0704_5-5F. It consists of ballistic armour protection panels fitted around the Flight Deck (including the floor and pilot seats) (Figure 27) and stowage for aircrew weapons (Figure 28). Both elements require extensive use of hook and loop fasteners for security of attachment and functionality.

1.4.379. At procurement, the manufacturer recommended that the life cycle of the hook and loop fastening be set at 200 cycles (1 cycle defined as attachment and removal of a panel). However, the life cycle was set at 3 years. The Panel noted that

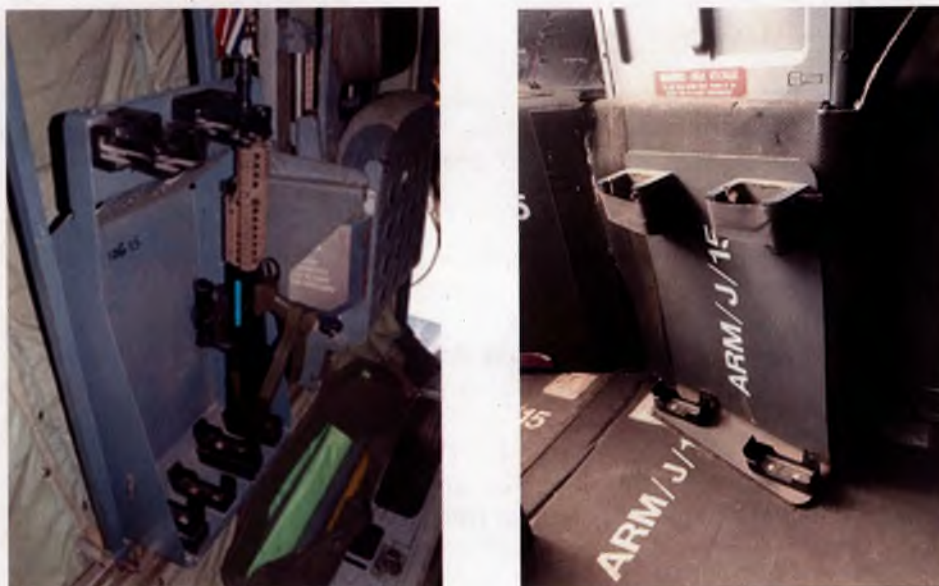
Figure 32 - Comparison of Weapon Stowage

1.4.390. The Panel also noted that the flight deck weapon stowage was not compatible with the L85A2 (SA80) Theatre Entry Standard (TES) rifle carried by the crew, having been designed for the L85A1 (SA80), that has a different hand guard. As can be seen in Figure 32, the upper securing assembly is located particularly close to the trigger guard, and is extremely tight on the modified hand guard (Quad Rail with Down Grip) making it difficult to insert the weapon.

1.4.392. This was in contrast to the stowage used in the rear cabin (Figure 32), which has a different securing arrangement without the issues identified above.

1.4.393. The Panel determined that the Weapon Stowage utilised on the flight deck, being designed for the L85A1/A2 (SA80), is incompatible with the L85A2 (SA80) Theatre Entry Standard rifle.

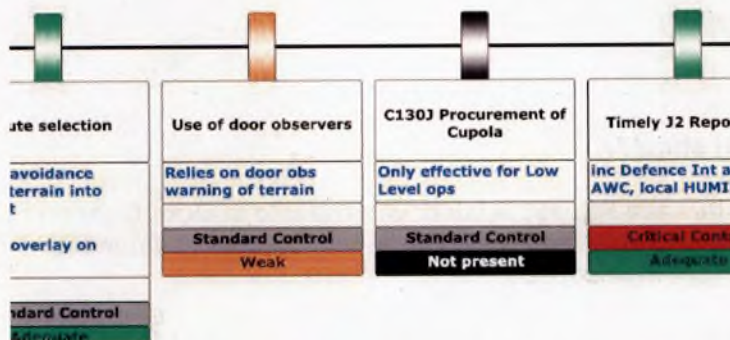
1.4.491. Although there had previously been a PSRR entry for the risk of injury to Door Observers, the Panel could not find a corresponding Bowtie where Door Observers were identified as a top event. This was confirmed by the Air Safety Cell at BZN, which indicated that Door Observers were only considered as a barrier in 2 other Bowties, namely "Attempted Engagement by the Enemy" and "Aircraft Operating in the Threat Band" as shown in Figures 38 and 39 below.

- a. **Ensure that the RtL associated with the use of Door Observers is ALARP and Tolerable, and founded on an objective, evidenced ALARP argument in accordance with RA1210.**
- b. **Identify all Risks to Life not transferred to Bowties from the PSRR in order to ensure they have been appropriately sentenced and remain under a robust risk management regime.**

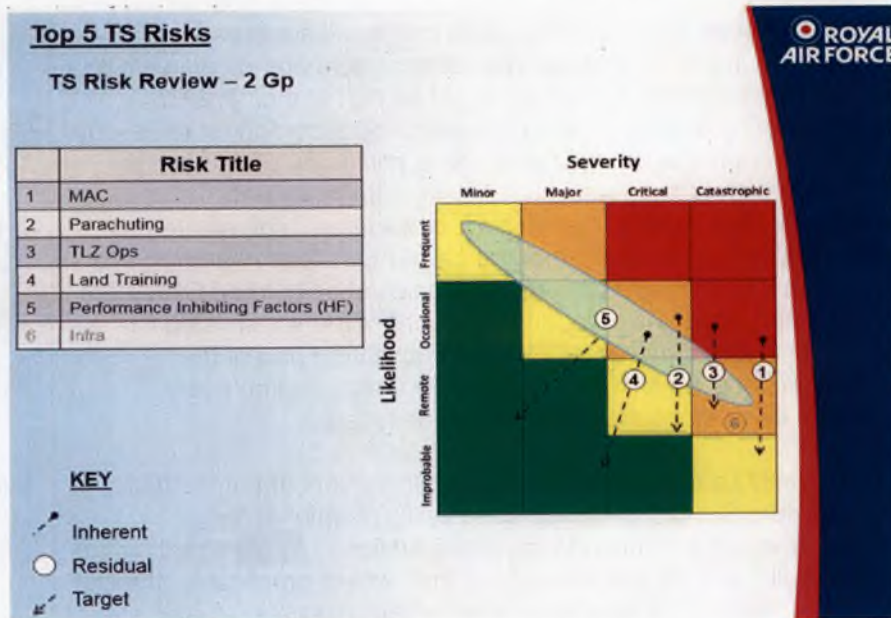
Figure 40 – 2 Gp Top Total Safety Risk Review²⁰

1.4.495. The Panel **Observed** that there was no Bowtie for TLZ Operations, despite it being listed as one of 2 Gp's 'Top 5 Total Safety Risks' (Figure 40). The only Bowtie referring to TLZs was one entitled '*Unauthorised Obstruction on the TLZ.*'

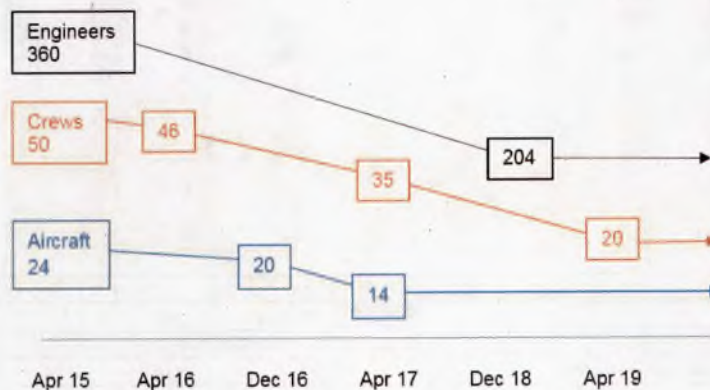
Figure 42 – Hercules Equipment and Personnel Staged Drawdown

1.4.605. The Strategic Defence and Security Review, 2015 (SDSR15), extended the Hercules Out of Service Date (OSD) from 2022 until 2035, albeit that the number of aircraft would reduce. A staged drawdown was planned, as highlighted at Figure 42.

1.4.606. This plan was based on a number of assumptions, one being that the A400M would absorb certain task lines, in particular the Falkland Islands from Nov 16, and the Broader Middle East, from Jun 17. Delays in that programme required the Hercules Force to maintain these tasks until Mar 18 and Nov 17 respectively, although the drawdown in personnel and airframes had already commenced and was not halted or reversed.

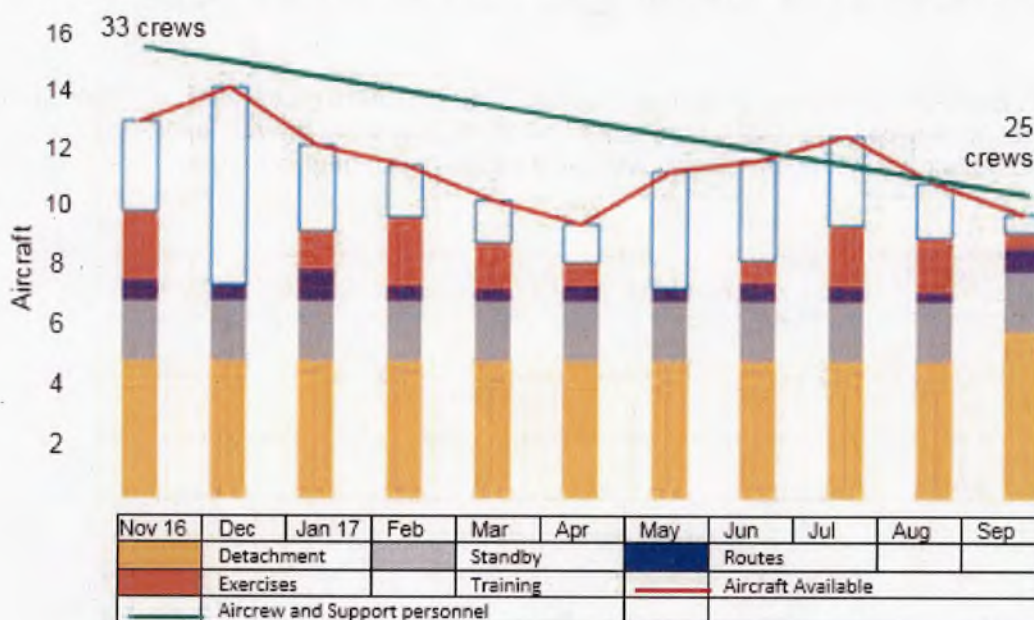
Figure 43 – 47 Sqn Task and Resource

1.4.610. Hercules Force Op Tempo and Resource, specifically as it affects 47 Sqn was discussed at length at the 2017 Hercules ASSWG. Utilising Figure 43, OC 47 Sqn articulated concerns that, during the year preceding the accident, planned manpower changes had resulted in a reduction of crews by 25% and air engineers from 354 personnel to 295. There had also been a reduction in the usable fleet by 7 aircraft, primarily resulting from the planned withdrawal of 4 Mk 5 aircraft and 2 accidents. However, the amount of tasking set to the Sqn remained broadly constant.

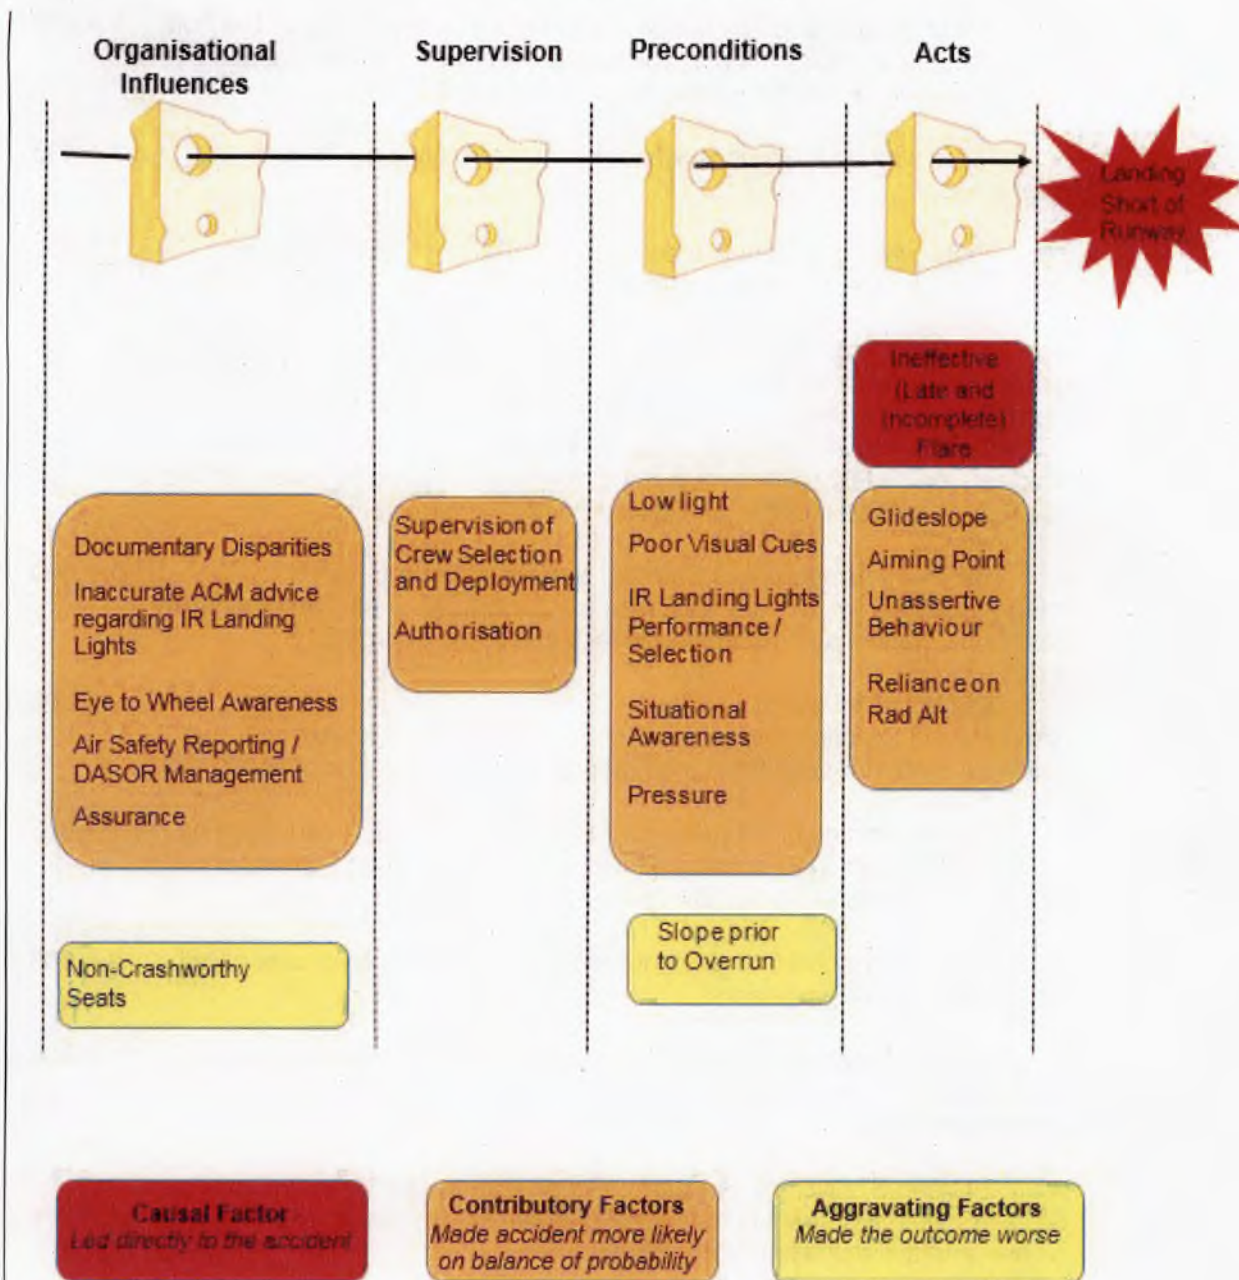
Figure 45 – Causal, Contributory and Aggravating Factors

1.4.688. **Accident Factor Summary.** The Causal, Contributory and Aggravating Factors concluded by the Panel are summarised in Figure 45.
